INSTALLATION OF A SOLAR DISTILLATION PLANT  
ON ILE DE LA GONAVE, HAITI

Ron Alward

May 1970

Internal Report No. I.67

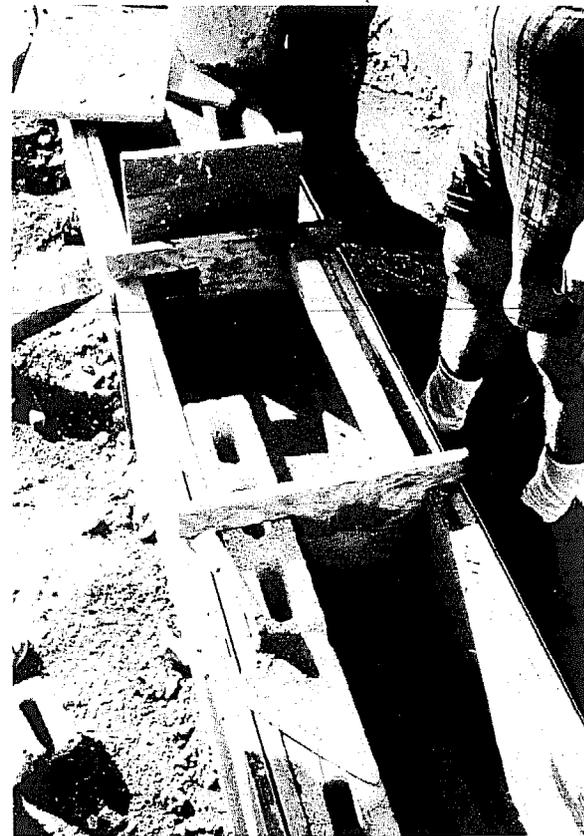
Fig 2: Special form used for positioning of concrete blocks and for moulding mortar and concrete into the shape of the gutters

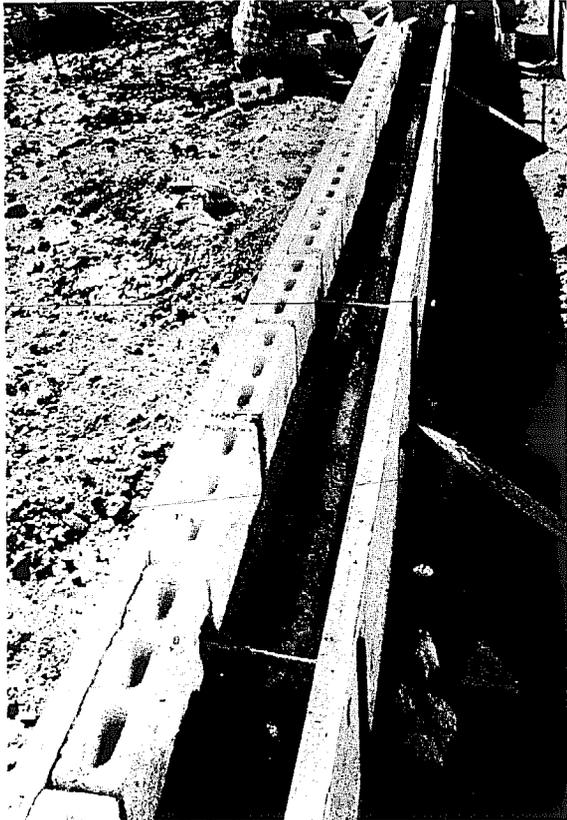
Fig 3: General view of partially completed curb wall, illustrating wood form work, rough gutters and concrete blocks. Note that at each tie wire, a bottom portion of the concrete block had to be chipped away. As noted in text, subsequent courses of concrete blocks were placed after tie wires had been removed

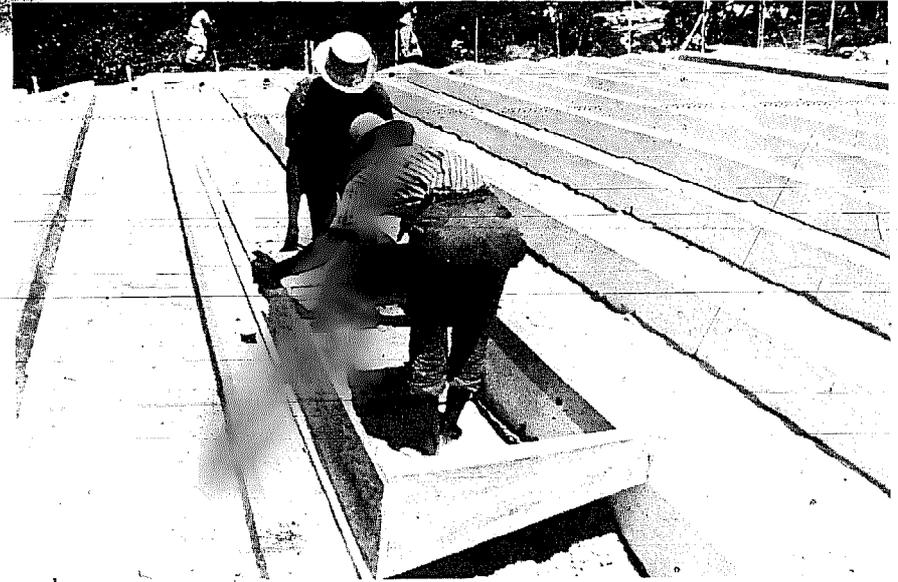
Fig 6: Finished curb and end walls with basin fill. The wooden frame is the guide used in levelling the basin fill in each of the twelve 6 foot long ponds that form one bay

The area between the curb walls was covered with a layer of beach sand up to a depth of four inches below the proposed level of the butyl rubber liner. The length of each basin was then split up into a number of six-foot sections. A large wooden frame (see Figure 6), some 7 feet in length, was built with appropriately sloping guides such that the sand in each of these six-foot sections could be levelled. This first layer of beach sand was well tamped and on top of this went a two-inch layer of dried coffee husks to act as insulation. This layer was levelled using the same wood frame with the levelling boards raised two inches. A second two-inch layer of beach sand was placed on top of the insulation, and again the area was well tamped. A series of two-inch high weirs were built from the sand, at the end of each six-foot section.

These weirs were installed to keep a uniform, shallow depth of water in a series of ponds down the length of each basin.
